**“Joint Management of Urban Wetland Areas in border region Latvia-Lithuania”  
Urb-Area Nr.LLI-472**

## **DAUGAVPILS AND ANYKŠČIAI URBAN WETLANDS MANAGEMENT PLAN**

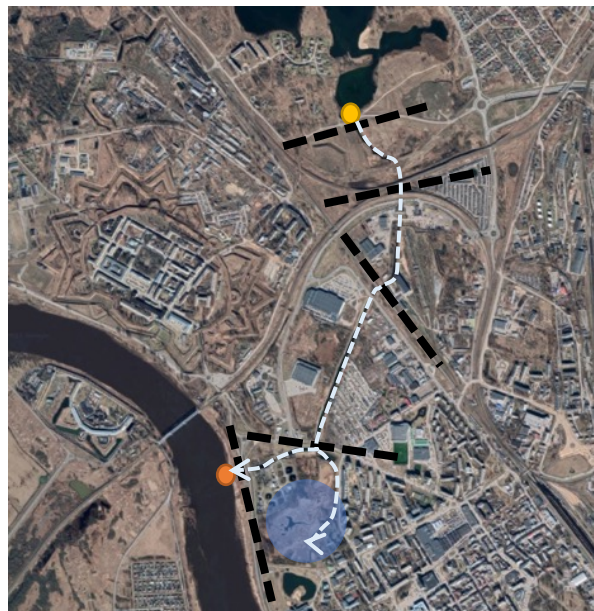
Figure 11. The landscape of the Šuņupe River

- - The outlet of the Šuņupe River from the Šuņezers; ● - The outlet of the Šuņupe River into the Daugava River;
- - The bed of the Šuņupe River and its course;
- - Esplanade Wetland; — - Artificial barriers in the riverscape - Urban transport infrastructure

The course of Šņūpe River and its connection to the Šņezers Lake have been preserved, but the natural hydrological regime of the area has changed significantly during the development of the city. As early as 1866, Russian army maps and Latvian army maps of 1920-1940 show a strong development of the railway and transport network, which fragmented the landscape of the Šņūpe River (Figures 9 and 10). Urban development has both altered the natural channel of the river and disrupted its course. Today, a fragmented riverscape has developed, which in its current state is not visually perceptible as a historically natural river landscape (Figures 11 and 12).

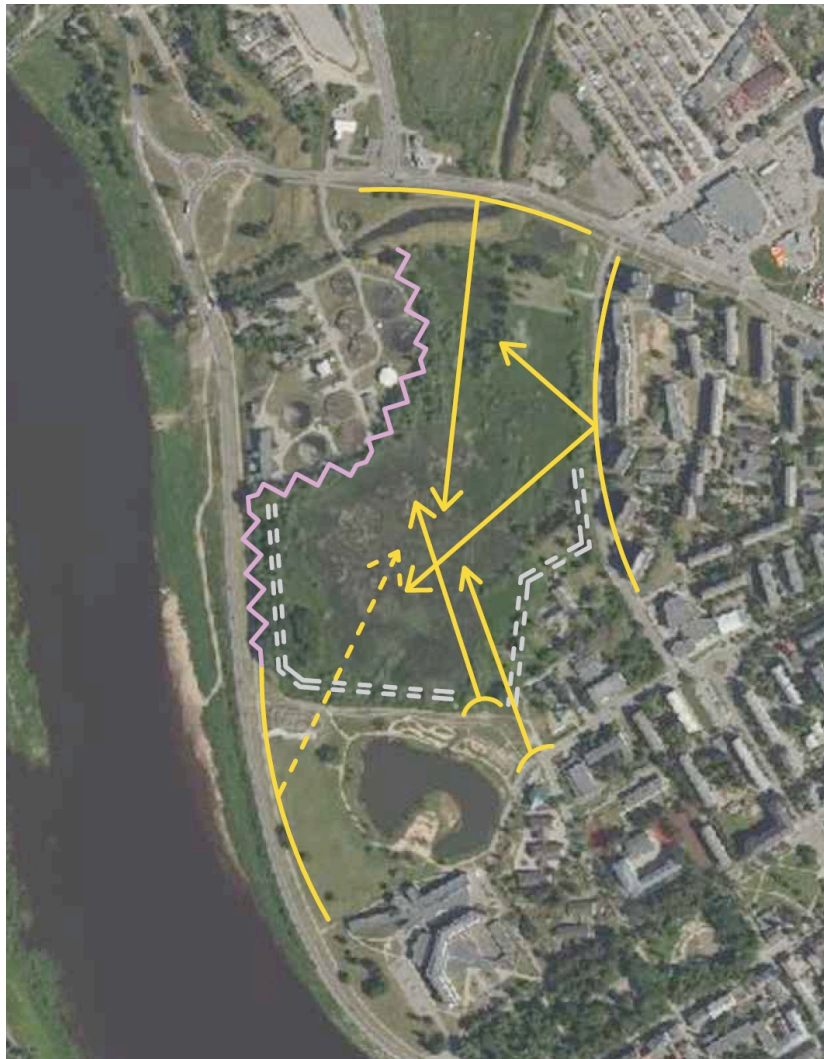
*Figure 13. Aesthetic qualities of the Esplanade Wetland.*

- - open sight lines
- - -→ - obstructed sight lines
- ~ ~ ~ - visual buffer
- = = = - visually inaccessible areas

The area is partially visible from Daugavas and Kandavas Streets and clearly visible from Cietokšņa Street and from high-rise residential buildings, especially the higher floors. The distant views provide a visual respite, which is not a common situation in densely built-up urban areas (Figure 13). As the Wetland is an important bird nesting site, the area is filled with bird sounds at certain times of the year, which provide a pleasure to the ear while at the same time reducing the noise from the urban environment.

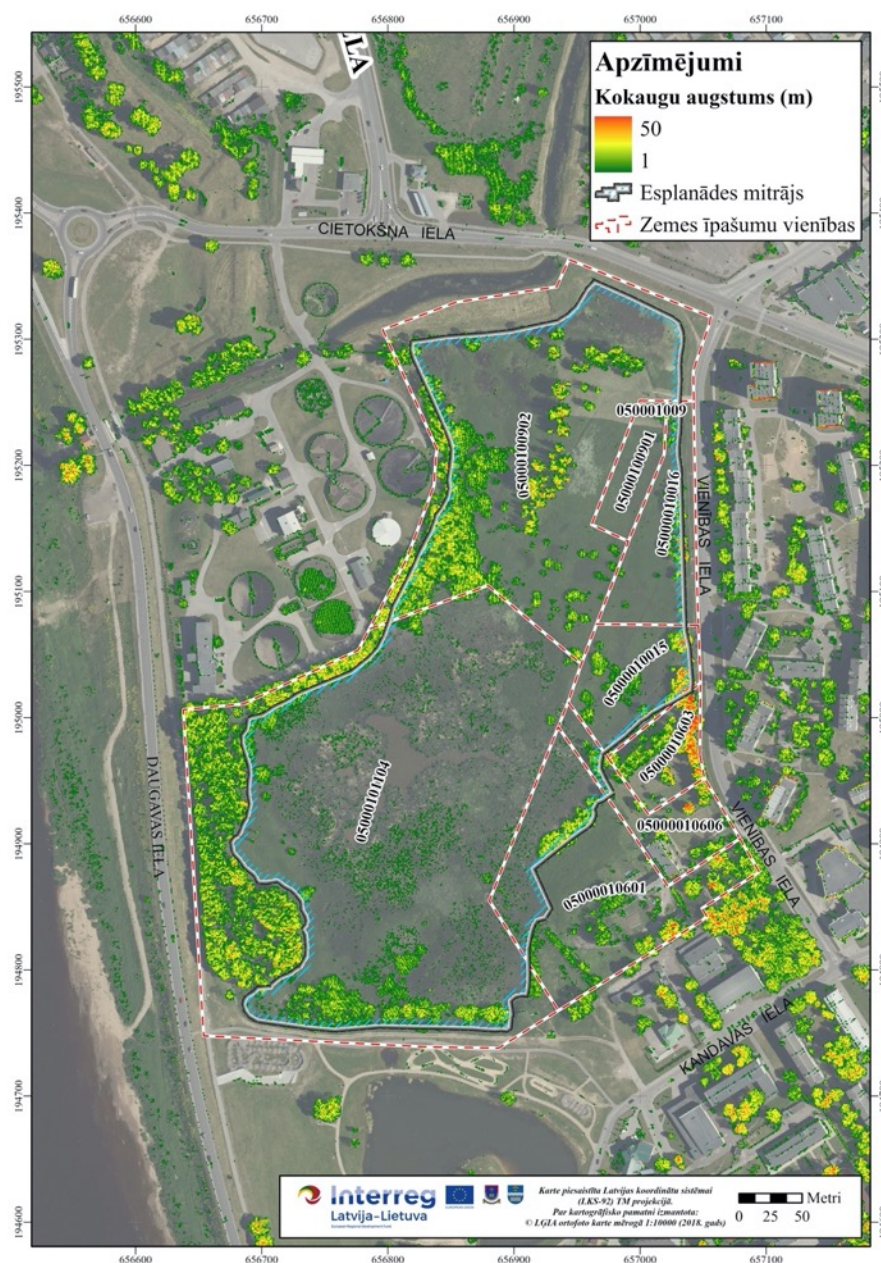
Figure 15. *LIDAR vegetation surface model*

The Esplanade Wetland is one of the lowest areas of the city, surrounded by man-made embankments and dykes. The Wetland is covered by aquatic and wet-loving plants in the lower areas and low-demanding native and invasive tree species in the higher and therefore drier areas. Native species are mainly deciduous woody plants - willows, maples, aspen, birches, etc. Invasive species - dogwoods, ashleaf maples. The Wetland vegetation is mainly formed by the highest woody vegetation along the perimeter, which partially reduces the visual accessibility of the site. The N part of the site consists of a wider tree cover - mainly willows, birches, maples and a planted group of larches. See Figure 15 for the LIDAR vegetation cover pattern.

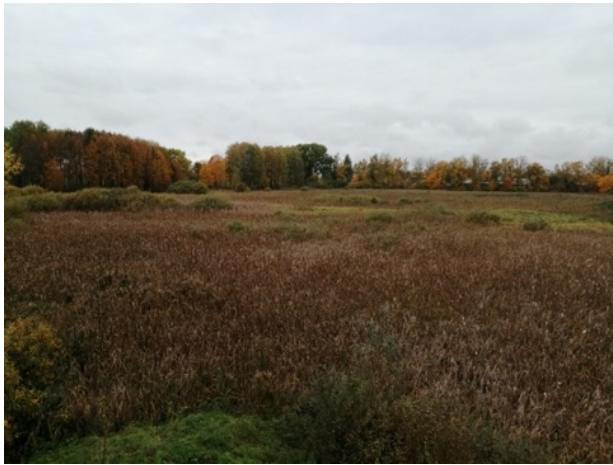
**Figure 16. Esplanade water body overgrown with common reed and bulrush (Photo: D. Krasnopolaska)**

The Esplanade Wetland is a water body overgrown with common reed *Phragmites communis* and bulrush *Typha latifolia*, where these species form monodominant stands (Figure 16), dominated also by reed sweet-grass *Glyceria maxima* and sedges *Carex* sp. In addition to the species already mentioned, the Wetland supports a variety of Wetland vascular plants, such as great willowherb *Epilobium hirsutum*, marsh willowherb *Epilobium palustre*, gipsywort *Lycopus europaeus*, cowbane *Cicuta virosa*, etc.

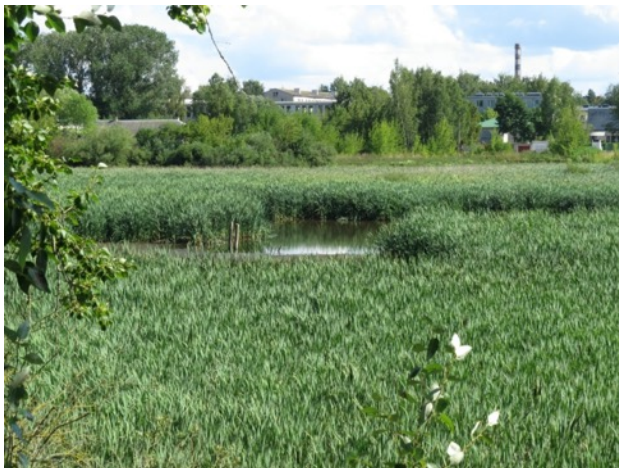
**Figure 18. Open water areas in the central part of the Wetland (Photo: A. Erts)**

The central part of the Wetland is covered by open water in small areas (Figures 18 and 19). The northern part of the Wetland is densely vegetated with shrubs (Figure 17), mainly dominated by willows *Salix* sp., but also with several invasive woody species.

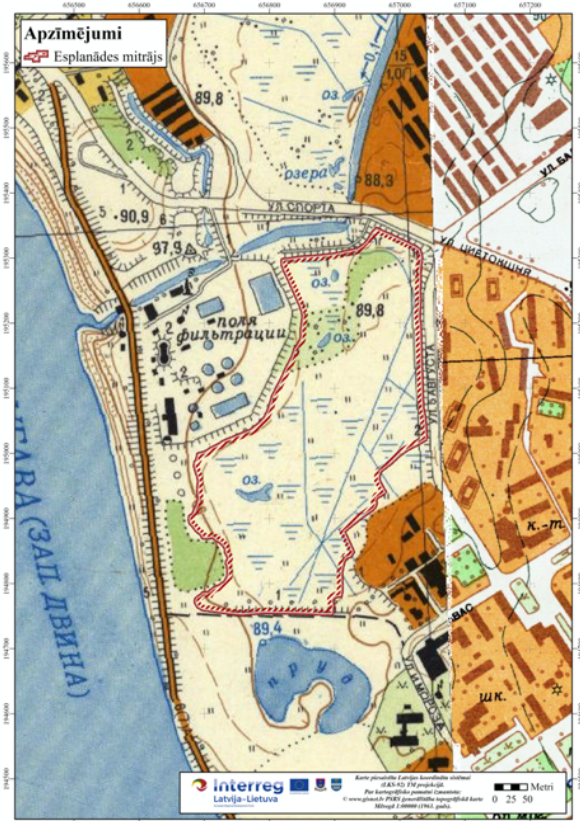
Figure 22. Esplanade Wetland area on the base of the USSR General Staff map of 1963

No specially protected Latvian habitats<sup>1</sup> were identified during the survey, however, historical photographs and maps (Figures 20-22) clearly show that the site of the existing Esplanade Wetland was reclaimed grassland, which was subject to hay mowing. The 1931 topographic map shows that the Esplanade water body is replaced only by a drainage ditch system (Figure 21). It is possible that the water body began to form as a drainage outlet at a time when the adjacent areas were being drained and developed (Figures 22 and 23).

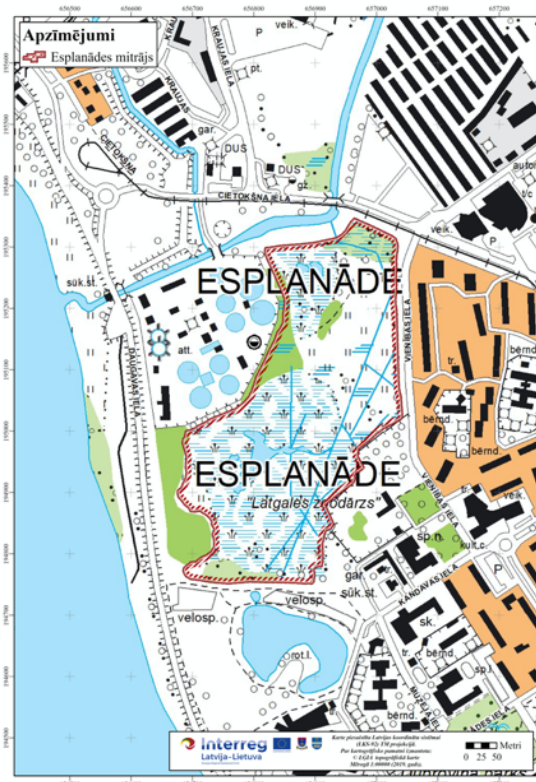
Figure 23. Esplanade Wetland area on the base of the 2012 topographic map prepared by the Latvian Geospatial Agency

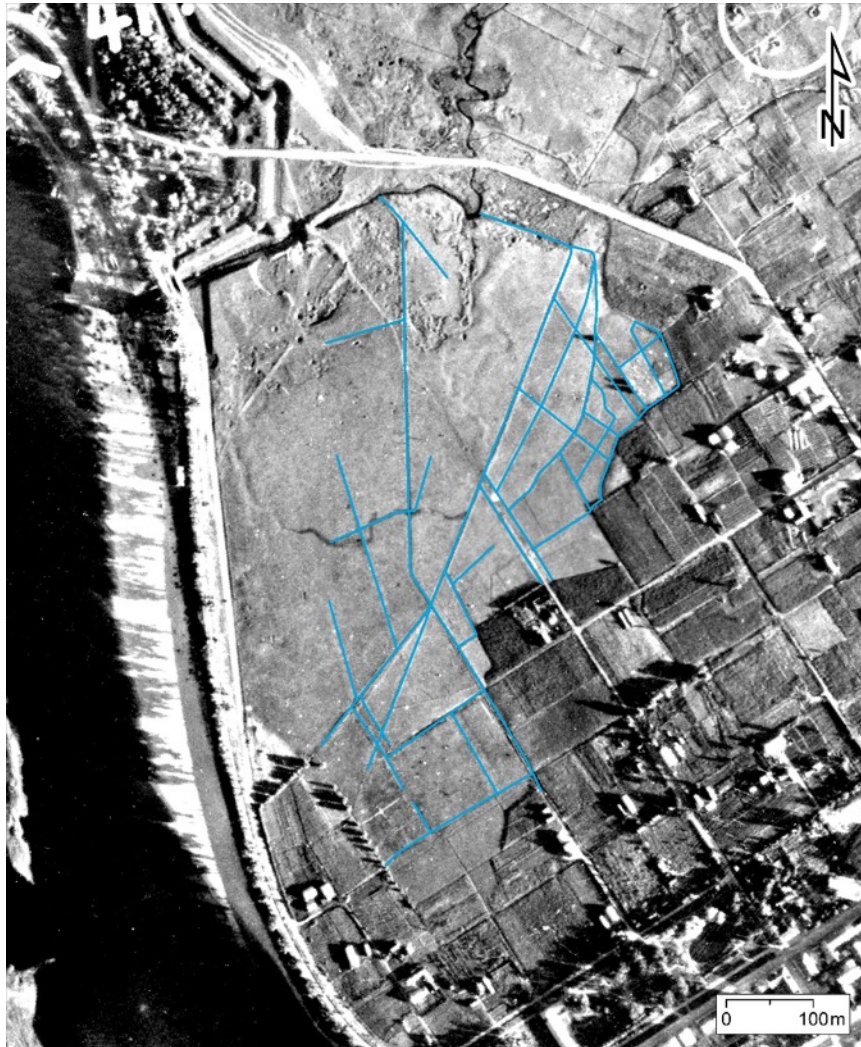
*Figure 32 Luftwaffe (Nazi German Air Force) vertical aerial reconnaissance photograph taken in 1944 - with blue lines indicating the location of drainage ditches*

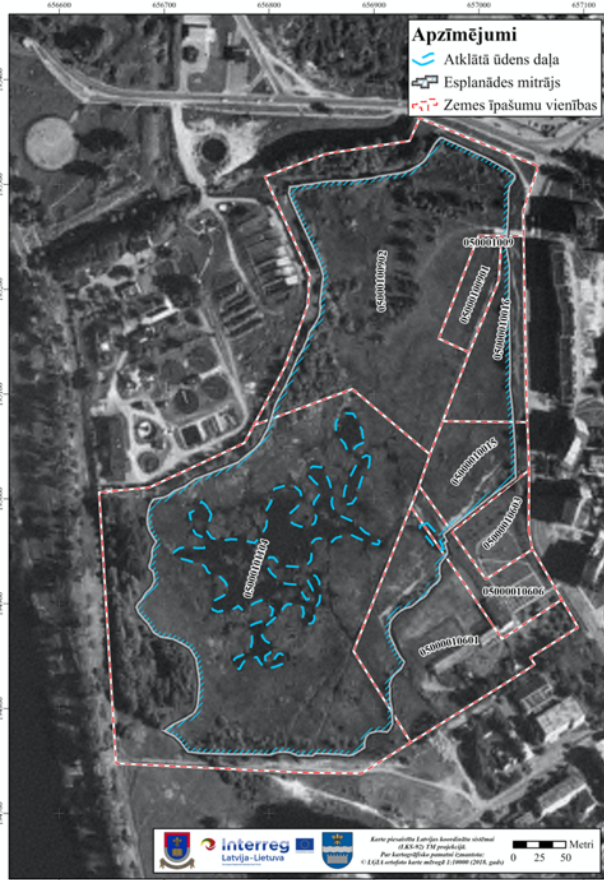
Figure 33. Open water fraction in the Wetland in 1995

Comparing the 1995 and 2017 data (Figures 33 and 34), the open water area of the water body within the Wetland has decreased by 78%, therefore, to maintain the hydrological regime, a water level regulation system is needed to ensure that the water level in the Wetland is stabilised and the surrounding areas are not flooded. This in turn would bring the Wetland closer to its natural runoff regime.

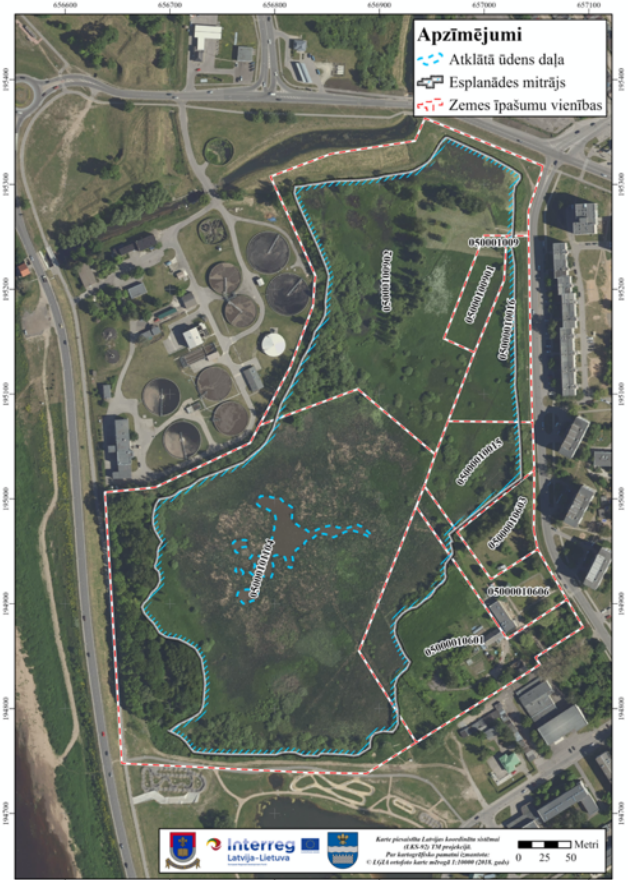
Figure 34. Open water fraction in the Wetland in 2017

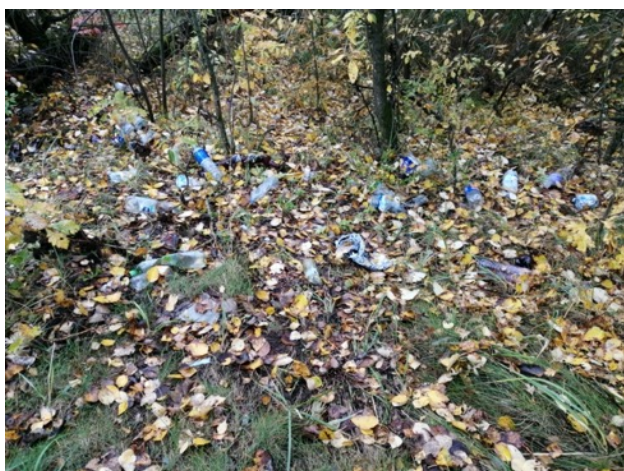
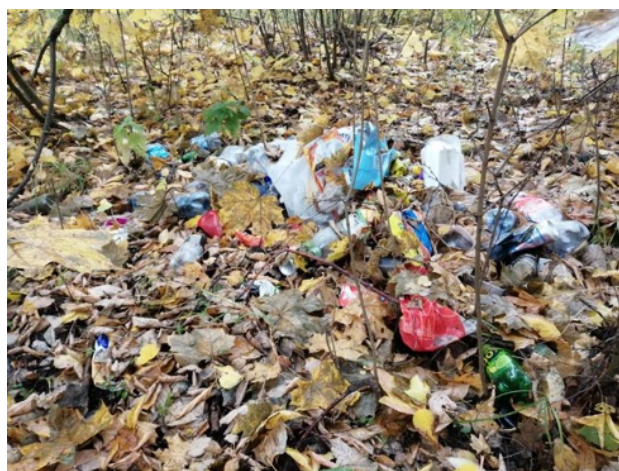
Figures 35 and 36. Contamination with municipal waste in the NW part of the Esplanade Wetland (Photo: D. Krasnopolska)

In the Wetland area, regardless of the lack of trails, there are negative human activities - household rubbish is often brought to areas overgrown with shrubs and tall plants (Figures 35 and 36).

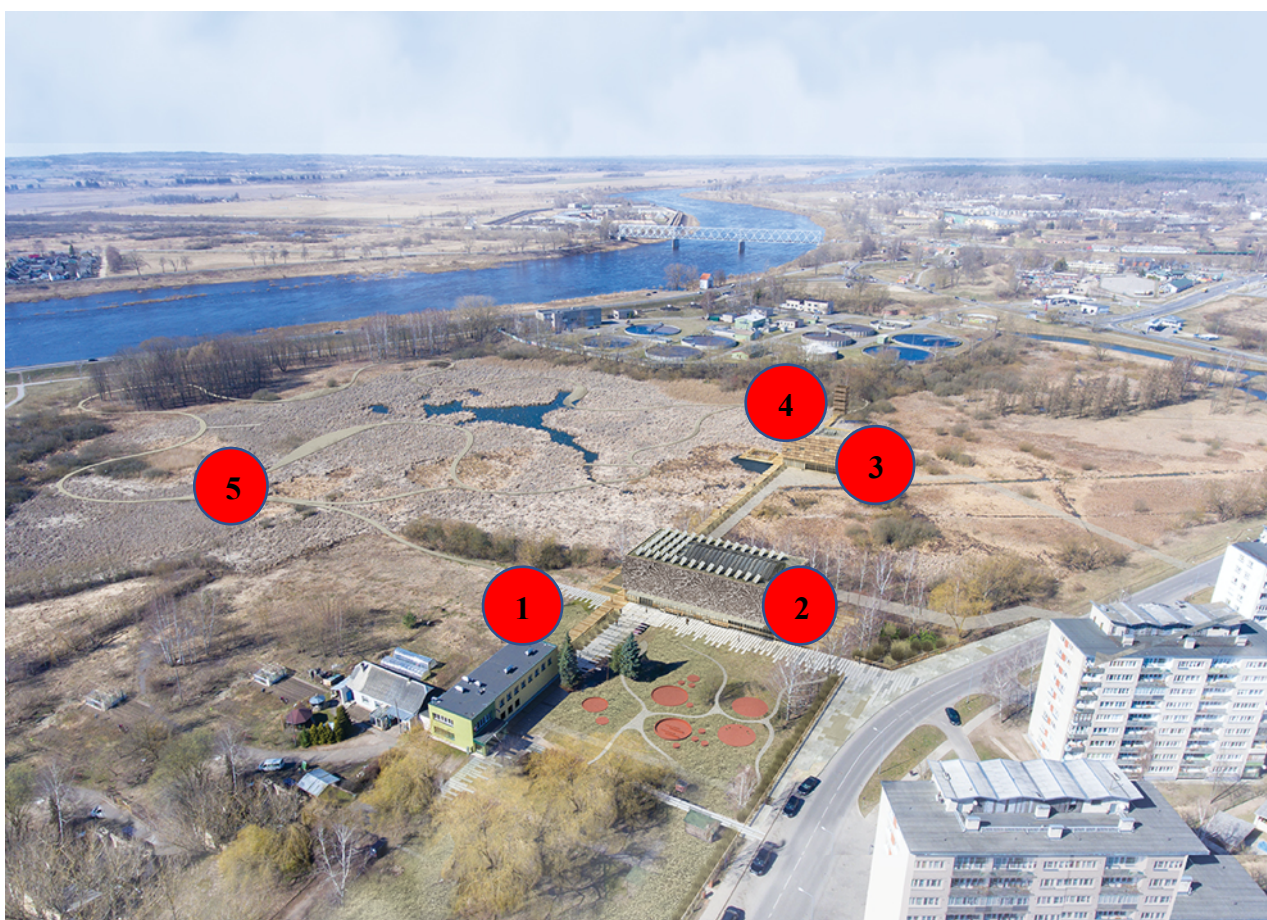
*Figure 45. Location of planned tourist and nature education objects in the territory of Esplanade Wetland (1 - existing building of Latgale Zoo, 2 - planned Jungle House, 3 - planned Swamp House building, 4 - planned viewing tower; 5 - planned trail route (image from the design prepared by "Trīs arhitektūra" and "Sudrana arhitektūra")*

The architects of the "Swamp Footbridge" project propose to create a swamp footbridge system with one central footbridge connecting the existing zoo building complex with the new buildings - the Jungle House, the Swamp House and the proposed viewing tower (Figures 45, 46 and 47).

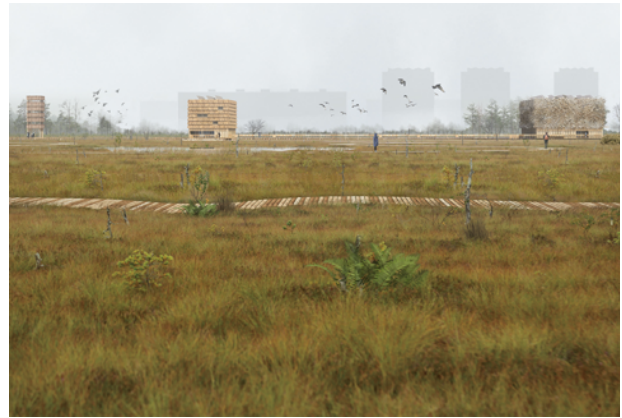
Figure 46. View from the footbridge of the planned Swamp House building (image from the design prepared by "Trīs arhitektūra" and "Sudrana arhitektūra")

The Wetland landscape is retained as the main dominating feature and the proposed architecture serves as a functional, subdued complement to it. The facades of the buildings use materials characteristic of the Wetland landscape - wood, reeds and tree branches. The Jungle House facade uses branches "fallen on the building" to evoke the surrounding birch trees, while the Swamp House facade is made of reed bundles. The facade of the lookout tower is made of braided branches. The interior of the exhibition spaces also uses materials that mimic material things and forms found in nature.

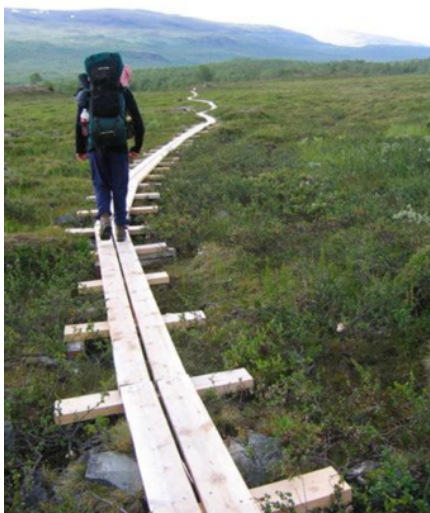
Figure 48. Visualisation of the planned "Herpetologist's Trail" section according to the construction design developed by BM Projekts

In addition to the central route, two additional thematic routes are to be developed - the "Herpetologist's Trail" and the "Ornithologist's Trail". The route of the planned "Ornithologist" trail is located in the forest area of the south-west side of the site along the Daugavas Street pedestrian and cycle path. "The Ornithologist's Trail is planned to be constructed of mineral surfacing (see Figure 49). The trail is designed to zigzag along existing trees, with natural obstacles such as fallen trees and other natural obstacles, as well as bird-watching hides. "The Herpetologist's Trail" is designed as a narrow wooden boardwalk on sleepers in places (see Figure 48), with a strip of mineral mix surfacing in places just to indicate the direction of travel.

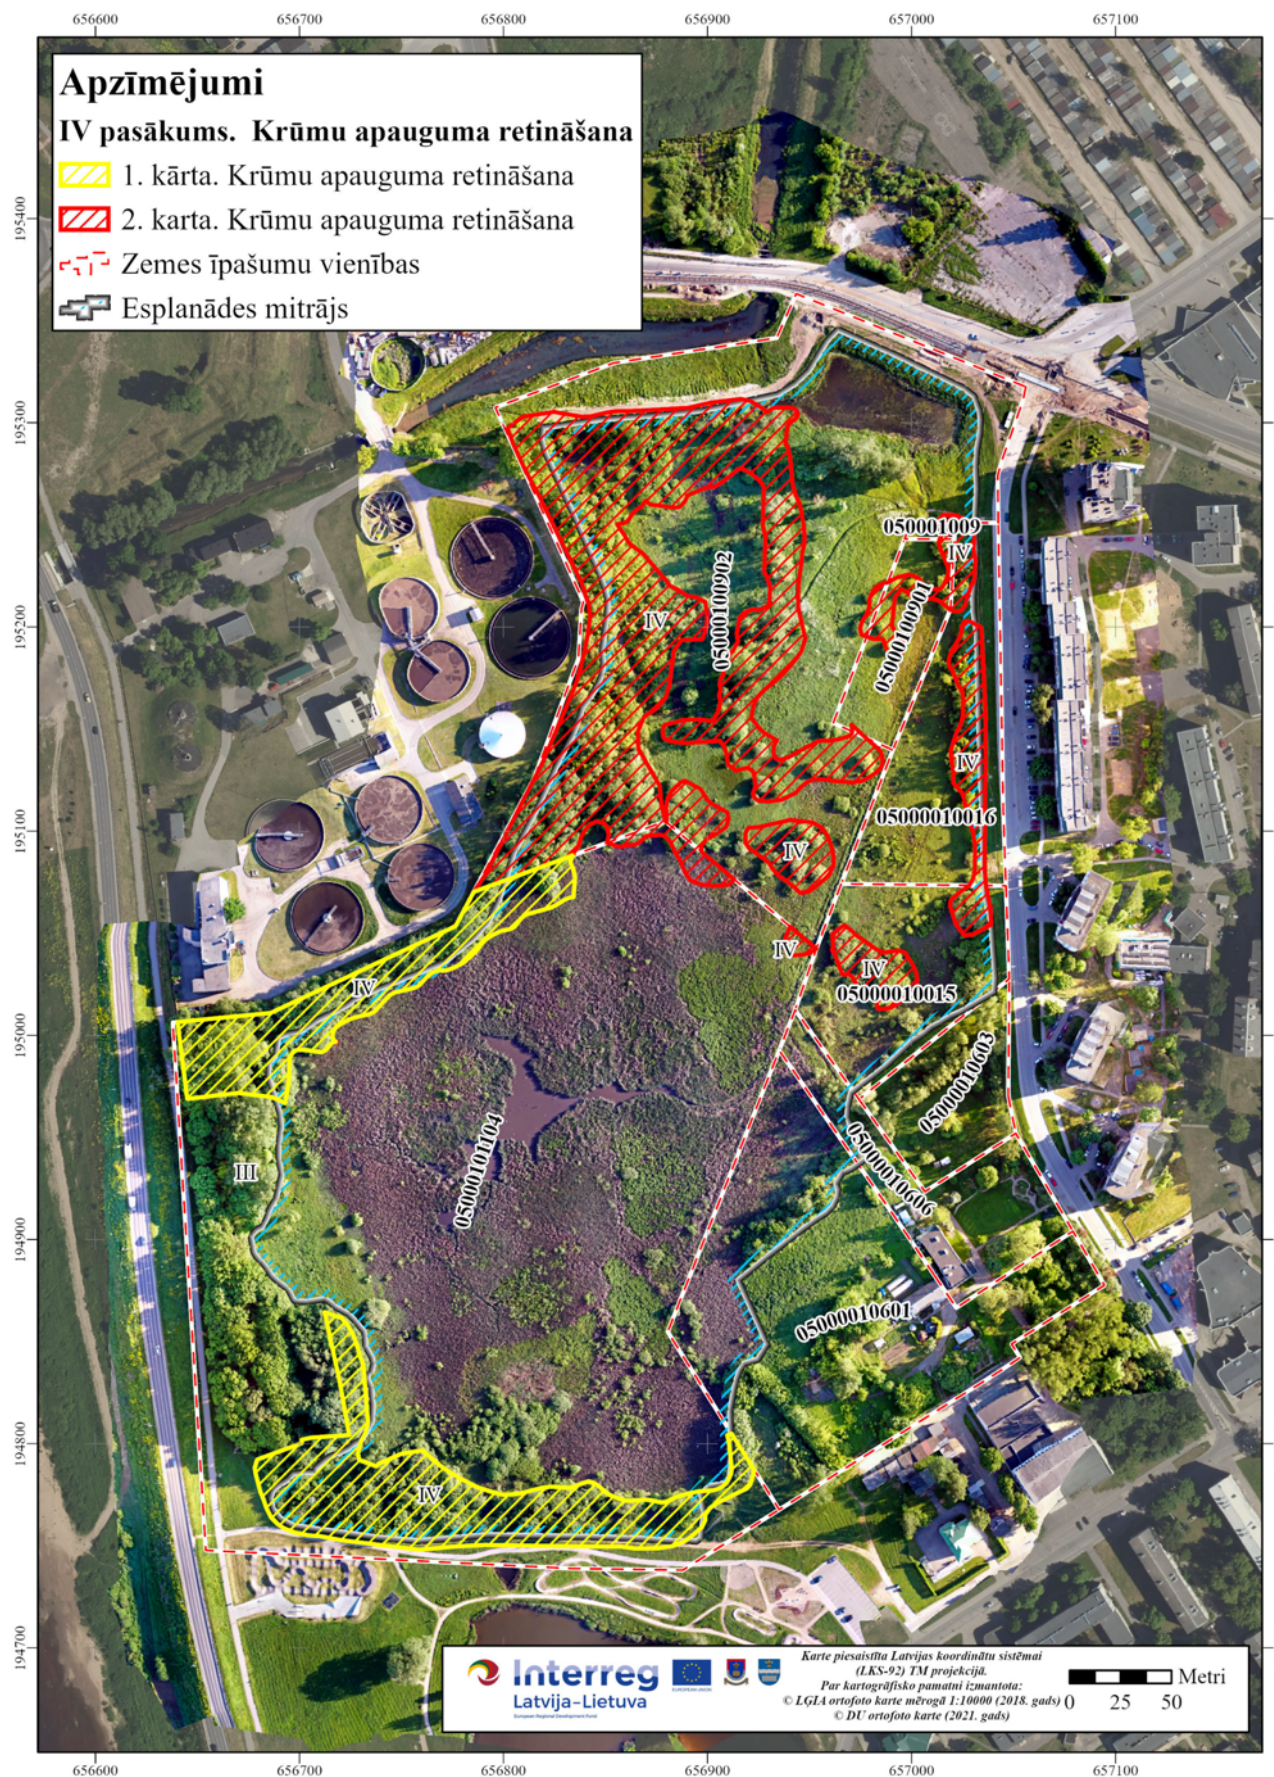
Figure 59. Sites of shrub thinning planned for Phase 1 and Phase 2

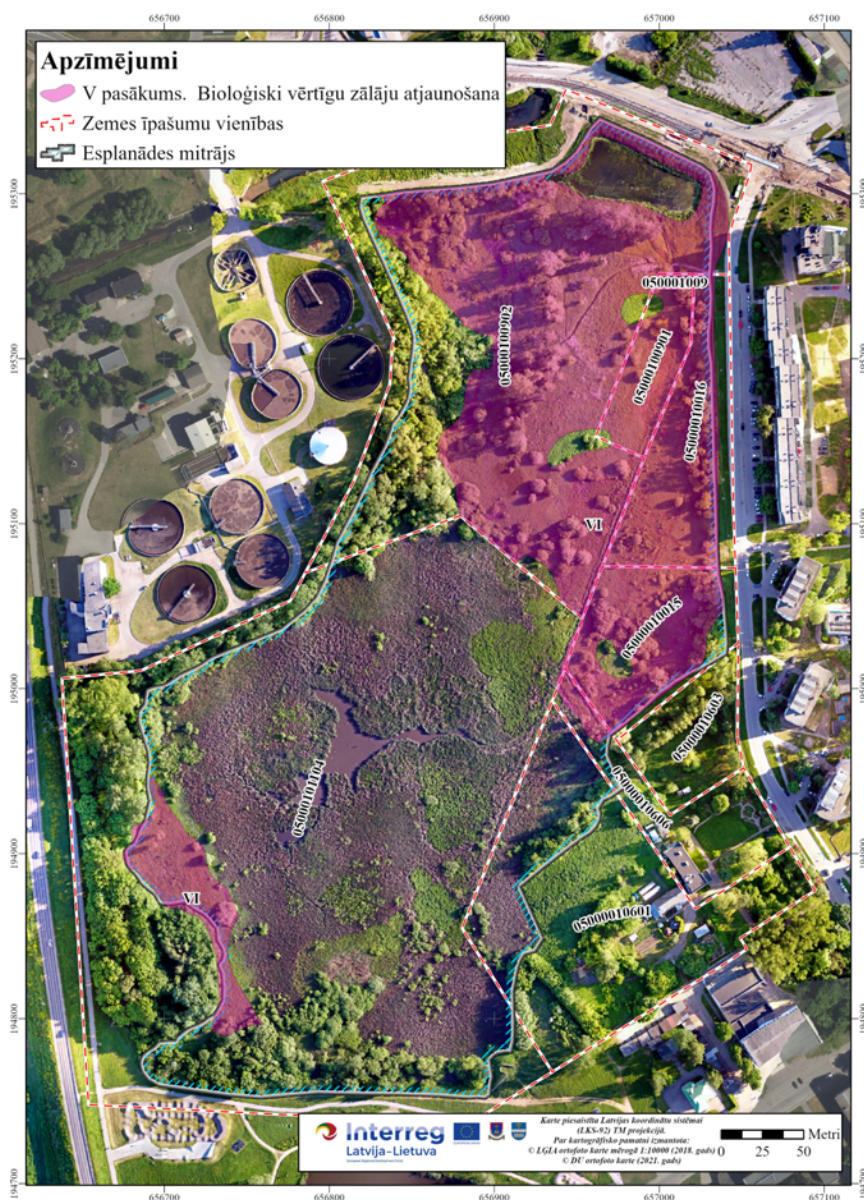
Figure 62. Areas where management of biologically valuable grasslands is recommended

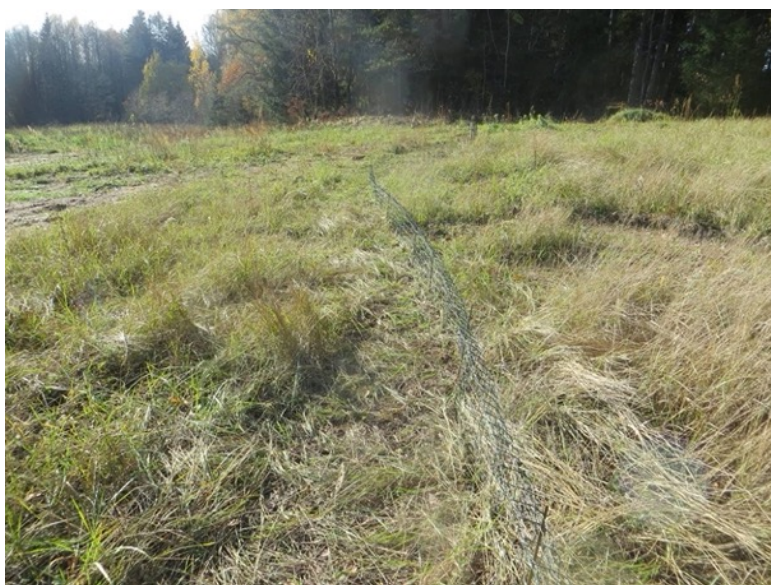
*Figure 63. Example of a fence - an example from the adjacent area of the amphibian breeding ponds created in the vicinity of the DU Study and Research Centre "Ilgas" (Photo: M. Pupiņš)*

The creation of a small fence is recommended to prevent juvenile birds and the European pond turtle (whose population is to be restored) from entering the roads. The installation of the fence is planned in two sections (Figure 64) - along Cietokšņa and Vienības Streets (approximately 430 m) and along the P67 road (approximately 260 m). Material of the fence: galvanised mesh painted green (Figure 63), mesh 5x5 cm, height of the fence 50 cm, of which 10 cm are buried in the ground and 40 cm above the ground, the upper 10 cm of which are bent inwards at an angle of 45-90°; the fence is supported by metal posts at intervals of ~ 1.5-2 m (depending on the micro-relief).

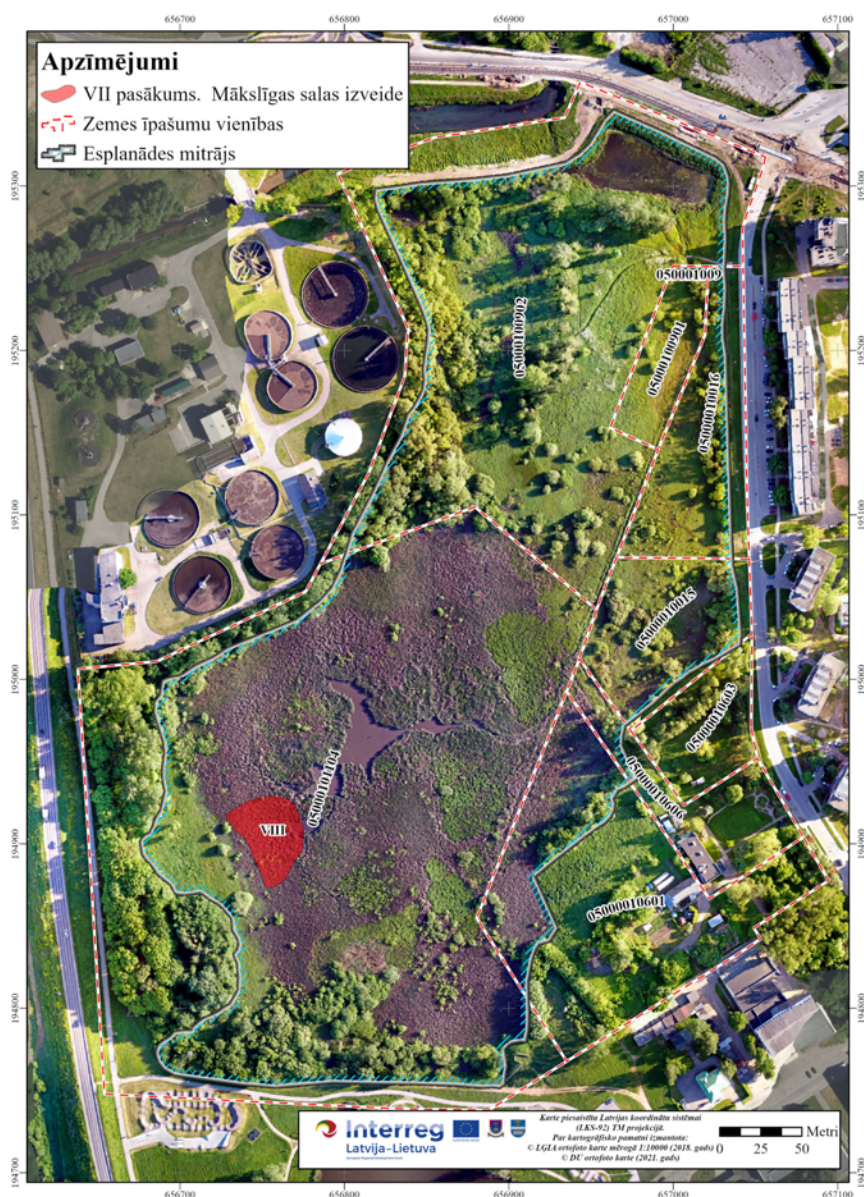
To increase the diversity of breeding and migratory bird species in the area, it is recommended to create an artificial island (Figure 65) suitable for the breeding of terns (common tern *Sterna hirundo*,

The island is to be created from the substrate of the pond bed to be dug in Phase 2 of Management Measure II. In order to provide favourable nesting conditions for the above bird species, the fertile soil layer of the created island shall be covered with geotextile or other material (to discourage dense vegetation) and a sand-gravel-pebble mixture shall be placed on top. Such an island can also be an important nesting site for terns and other bird species, as well as a resting place during migration periods. Therefore, the creation of such a site in the Esplanade Wetland would contribute to the development of the area as a bird-watching site.

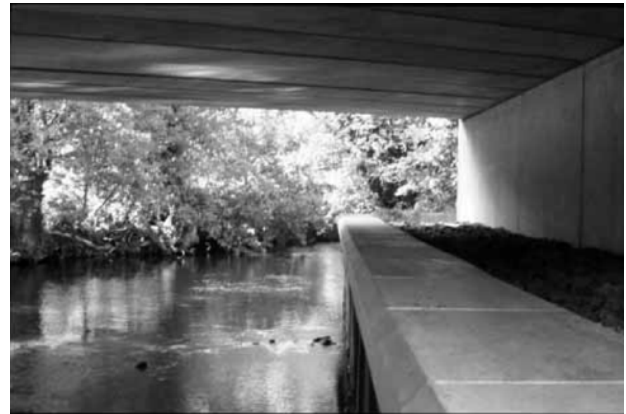
Figures 68 and 69. Large culvert with shelves to allow animals to safely cross the road (Photo: Grogan et al., 2001)

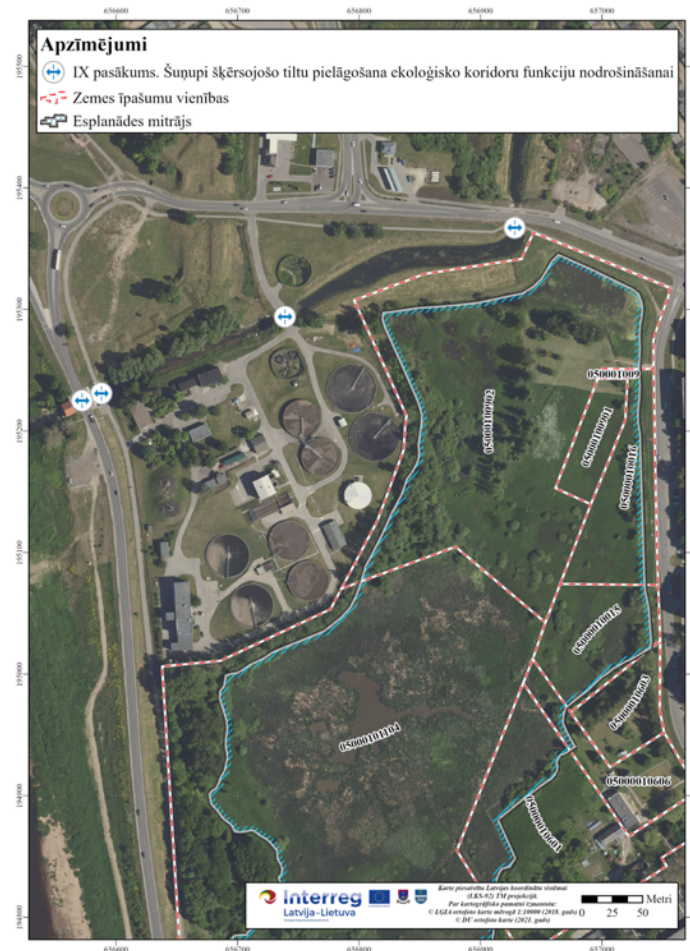
Figure 70. Bridges crossing the Šunupe River that need to be adapted to ecological corridor functions

In cases when reconstruction of streets crossing the river is planned, it is recommended to provide technological solutions for adaptation of bridges and culverts (Daugavas Street Bridge, Cietokšņa Street Bridge and the bridge at the entrance to the water treatment plant) to ecological corridor functions during the development of technical projects. The adaptations include the creation of small shelves or additional culverts (Figures 68 and 69) under the bridges on both banks in such a way that animals from one side of the road can get under the bridge on the other side. Currently, roads are an insurmountable barrier for several mammal species. Shelving under bridges is also particularly important for otters. The tunnels should be designed to allow medium-sized mammals such as otter and fox to pass through. If necessary, the tunnel can also be adapted for human use.

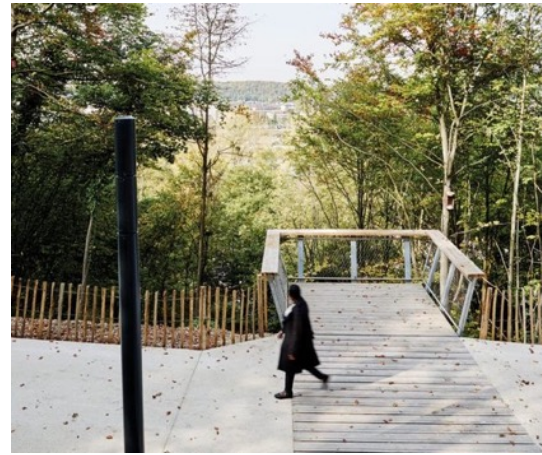
*Figure 75. Example of a viewing platform*

habitats. Along the rampart part of the WWTP, the footbridge should be built at the foot of the rampart, with small platforms in some places on the higher part of the rampart (Figures 74, 75, 76 and 77). It is recommended that the embankment in S part of the Wetland be used as a viewing platform and birdwatching site.

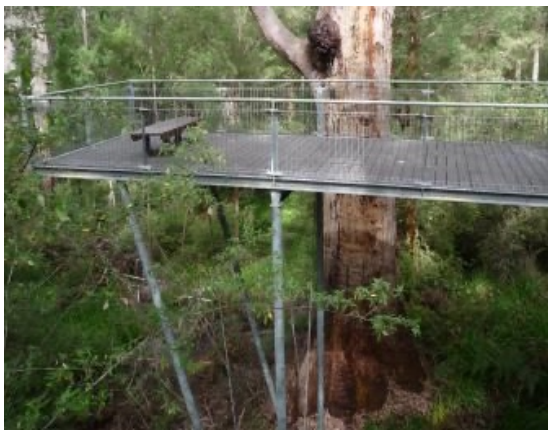
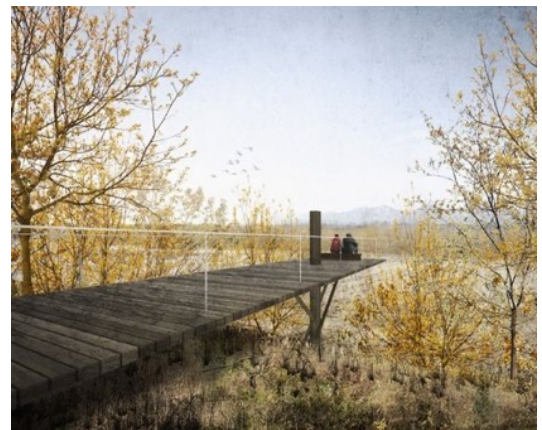
*Figures 76 and 77. Example of a viewing platform*

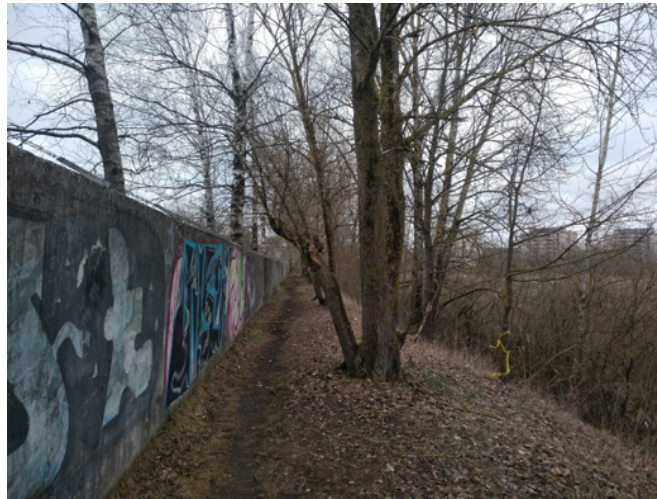
*Figure 78. Existing concrete fencing and footpath (Photo: U. Valainis)*

It is recommended to remove the existing footpath along the higher part of the revetment along the concrete fence of the WWTP area (Figure 78). The existing concrete fencing is recommended to be visually improved by painting it in a uniform shade, and by adding wooden plank panels in some areas that are visually accessible, such as the viewing platforms planned for the top of the rampart (Figures 79 and 80).

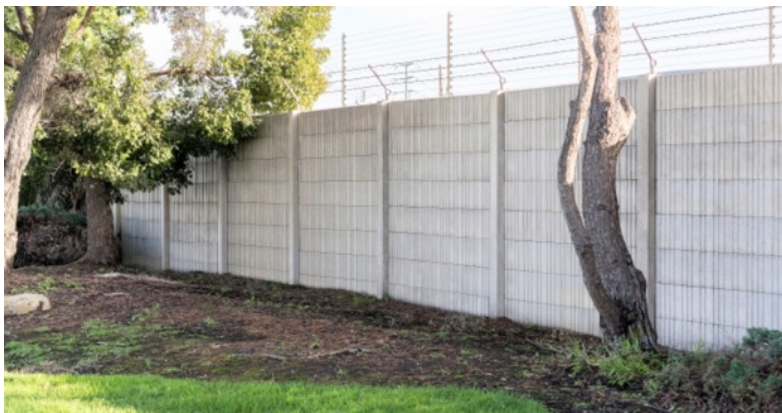
*Figure 79. Example of concrete fencing colour*

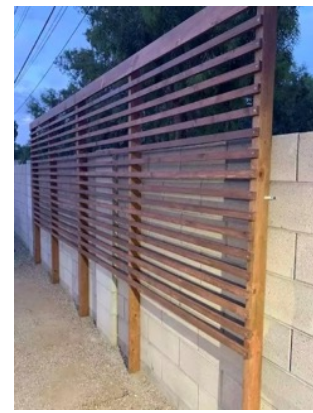
*Figure 80. Concrete fencing wooden plank panels*

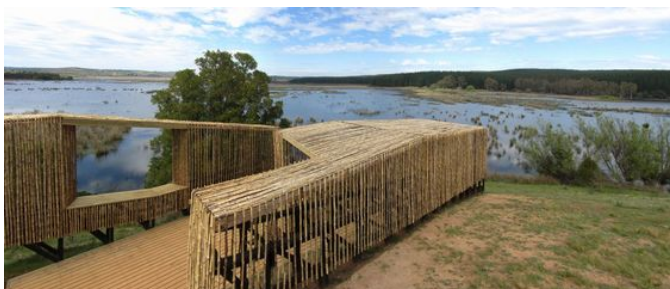
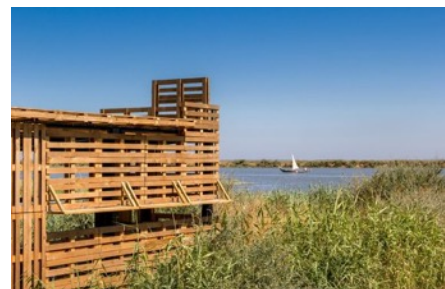
*Figures 81 and 82. Examples of observation hides*

It is recommended that the footbridges be elevated on stilts, with small hides and platforms for birdwatching in some places, and that some sections of the trails be closed so as not to disturb wildlife (Figures 81, 82, 83 and 84). It is recommended to add educational content to the observation points. It is also desirable to install information signs and signs in a uniform design along all sections of the boardwalk (Figures 85, 86 and 87).

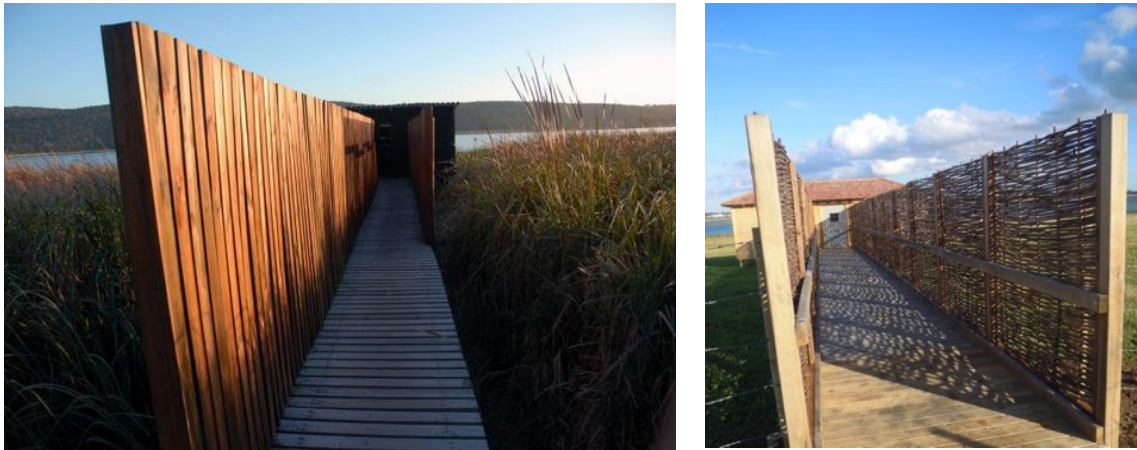
*Figures 83 and 84. Panels blocking the view of the path*

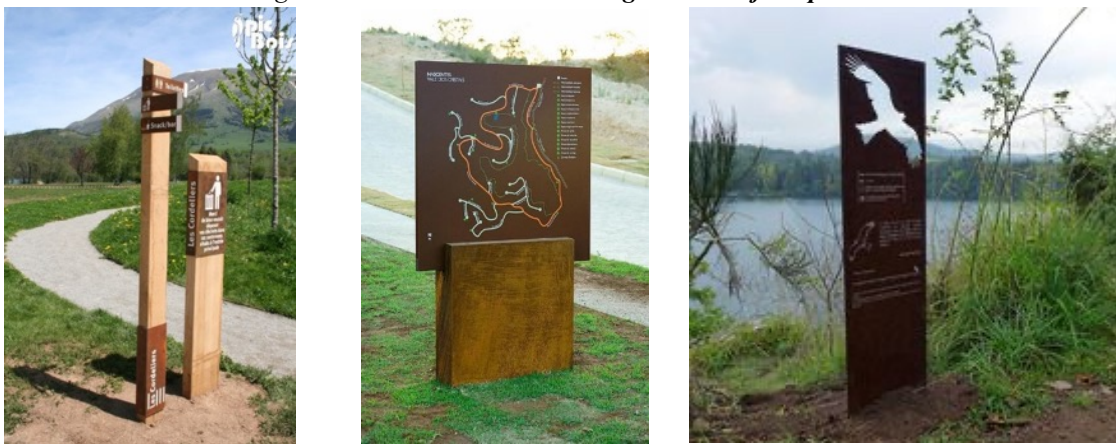
*Figures 85, 86 and 87. Examples of information boards and signs*

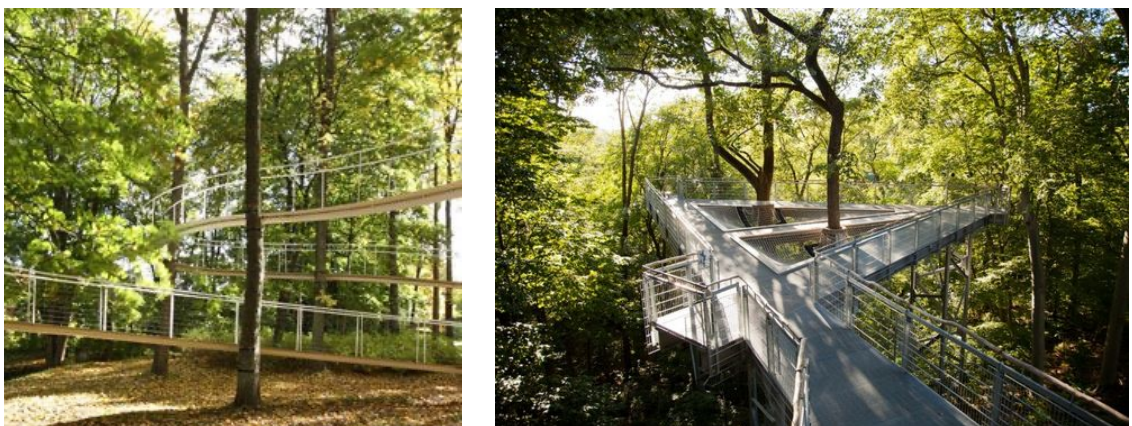
*Figures 88 and 89. Examples of walking trails in trees*

In addition, walking paths can be created in the trees between the existing trees to be preserved in the part near the fenced off dog area, allowing to explore the surroundings from an elevated position (Figures 88 and 89).

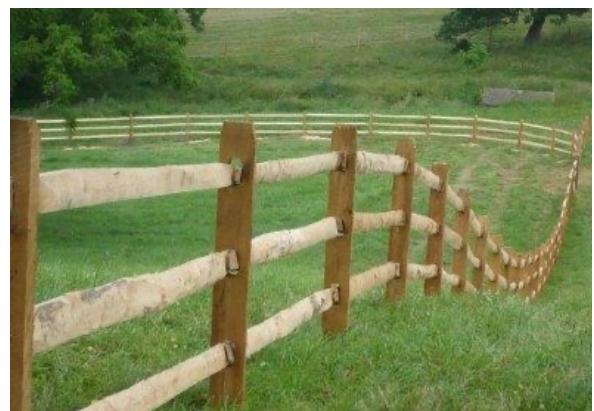
*Figure 91. Example of a wooden fence in a bio-meadow restoration area*

*Landscaping.* It is recommended to install a self-contained low fence or fencing (Figure 91) in the zone, thus visually and physically separating it from the rest of the freely accessible area - the quiet recreation zone. Along the SE and NW edges of the zone, create a network of footbridges connecting to the Wetland zone footbridges and the peaceful recreation zone footpaths. The boardwalks shall be constructed slightly elevated above the understorey, taking into account environmental accessibility and safety conditions. It is recommended that benches overlooking the pastures be built in some places in the footbridge extensions. It is recommended that the benches are made of natural material without backs, thus ensuring that people do not remain in one place for long periods, and that they are stylistically consistent throughout the Wetland area. Use timber (Figure 92) or galvanised steel grating (Figure 93) for the benches.

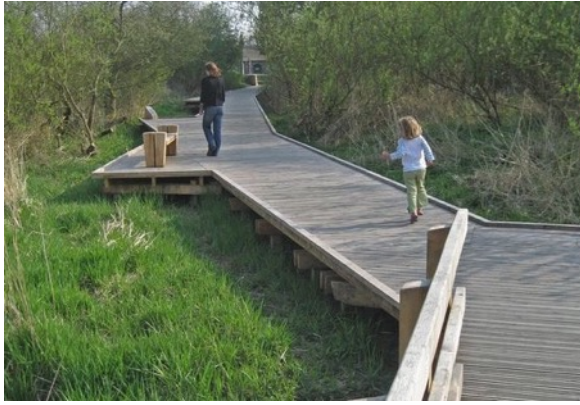
Figure 92. *Example of a raised wooden footbridge with seating benches*

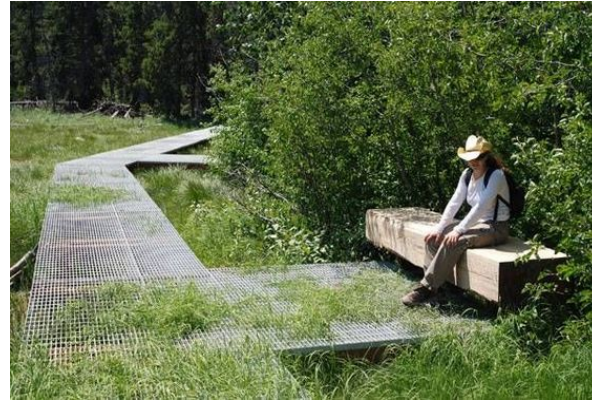
Figure 93. *Example of a raised galvanised steel lattice walkway with seating benches*

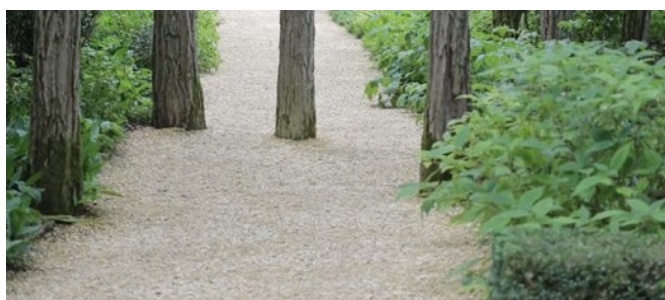
*Figure 95. Example of a paved path*

*Landscaping.* The area is designed as a peaceful recreation area - mainly for local residents. A network of paths is recommended in the area, connected to the common Wetland and biological meadow walking route. Entrances to the park are planned from Vienības and Cietokšņa Streets. It is recommended that the walking paths be made of loose surfacing materials (Figure 95), and that wooden footbridges be built where the paths cross the existing ditch system. The area should be complemented by benches in a style consistent with the landscaping used in the rest of the Wetland. In addition, it is recommended to improve the approaches to the Šņūpe River and the adjacent pond by creating small platforms on their banks (Figure 96). It is recommended that this part of the site be illuminated to maximise accessibility and safety at all times of the year, especially at dusk.

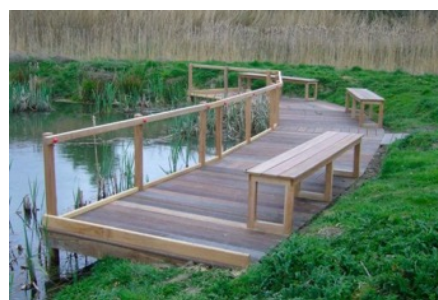
*Figure 96. Example of platform near waterbodies*

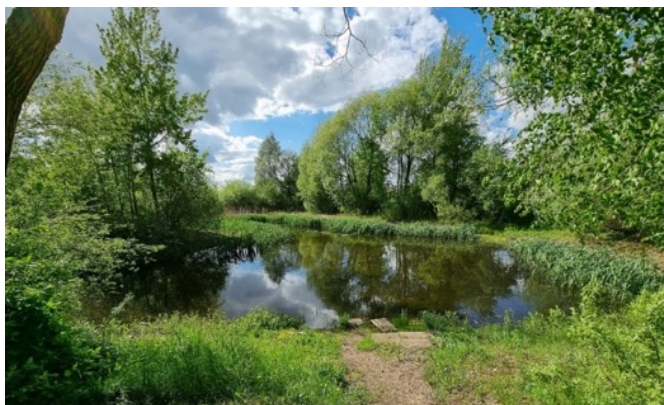
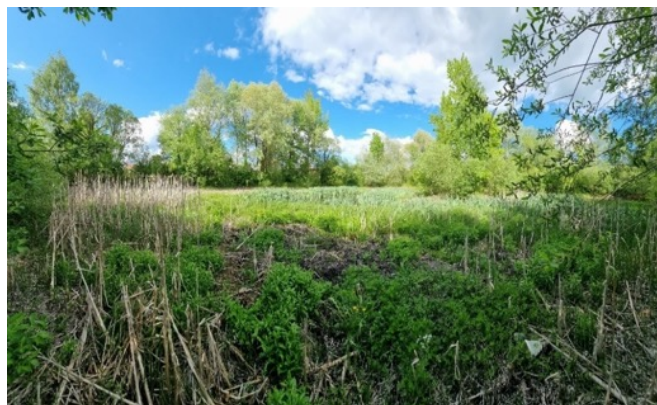
In spring and summer of 2021 the water surface of the Green pond looked pretty different than in the orthophotograph made in 2018 (Figure 100). There was left about 1/3 of free water surface in May 2021 and even less in July-August 2021 (Figure 101 and 102). The shallow Northern and Western parts of the pond overgrown by dense helophyte (mainly *Typha latifolia* and *Equisetum palustre*) stands, it was possible to walk in these parts of the pond. Because of decreased water table in summer of 2021, the small island in the middle of the Green pond has joined to the shore. Rubber boots were not necessary to reach the island in August 2021.

Figures 101 and 102. A great part of water surface of the Green pond became into a land in 2021 (Photo: A. Balevičius)
