**“Joint Management of Urban Wetland Areas in border region Latvia-Lithuania”  
Urb-Area Nr.LLI-472**

## **DAUGAVPILS AND ANYKŠČIAI URBAN WETLANDS MANAGEMENT PLAN**

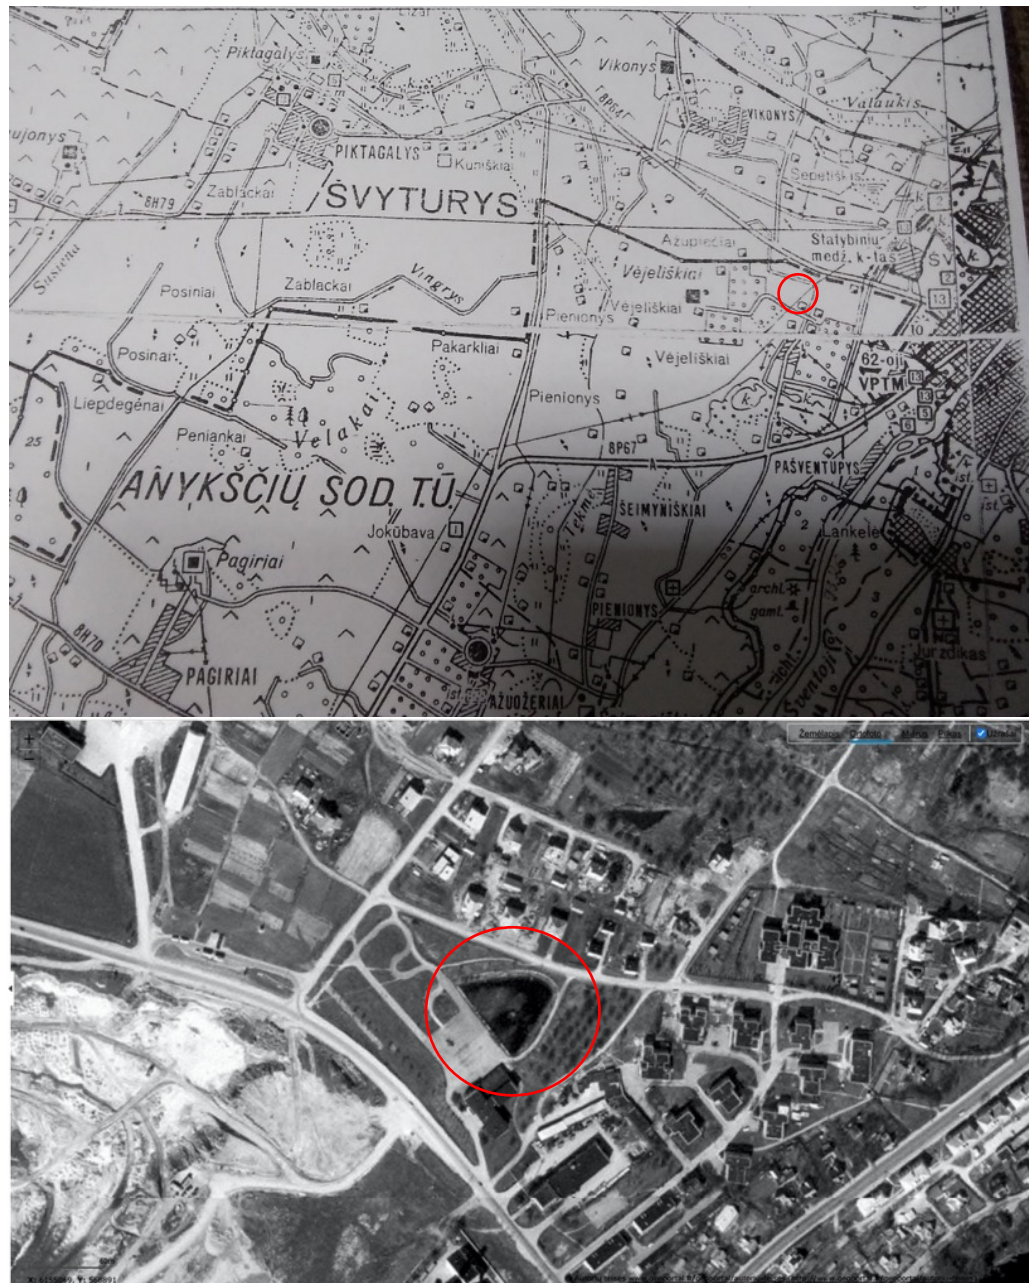
Today's Green pond is the waterbody of an artificial origin. We could not find the exact date when it was excavated and for what purpose, but it could be excavated in VII – VIII decade of the 20th century. Pond clearly exists in old aerial photographs, but can't be seen in topographical maps (probably because of its' small size) (Figure 103).

Figures 103 and 104. Anykščiai Green pond place in old maps (1977 – 1986) and orthophotograph (1995-1999) (from [www.geoportal.lt](http://www.geoportal.lt))

The territory around the Green pond is rich in sand and gravel. Quartz sand factory is still working in 400 meters to the North and West, earlier there were quartz sand mining sites nearby the factory. So today's Green pond could be the remain of these massive excavations. Another purpose of the pond could be a water-body for fire extinguishing or watering the garden nearby.

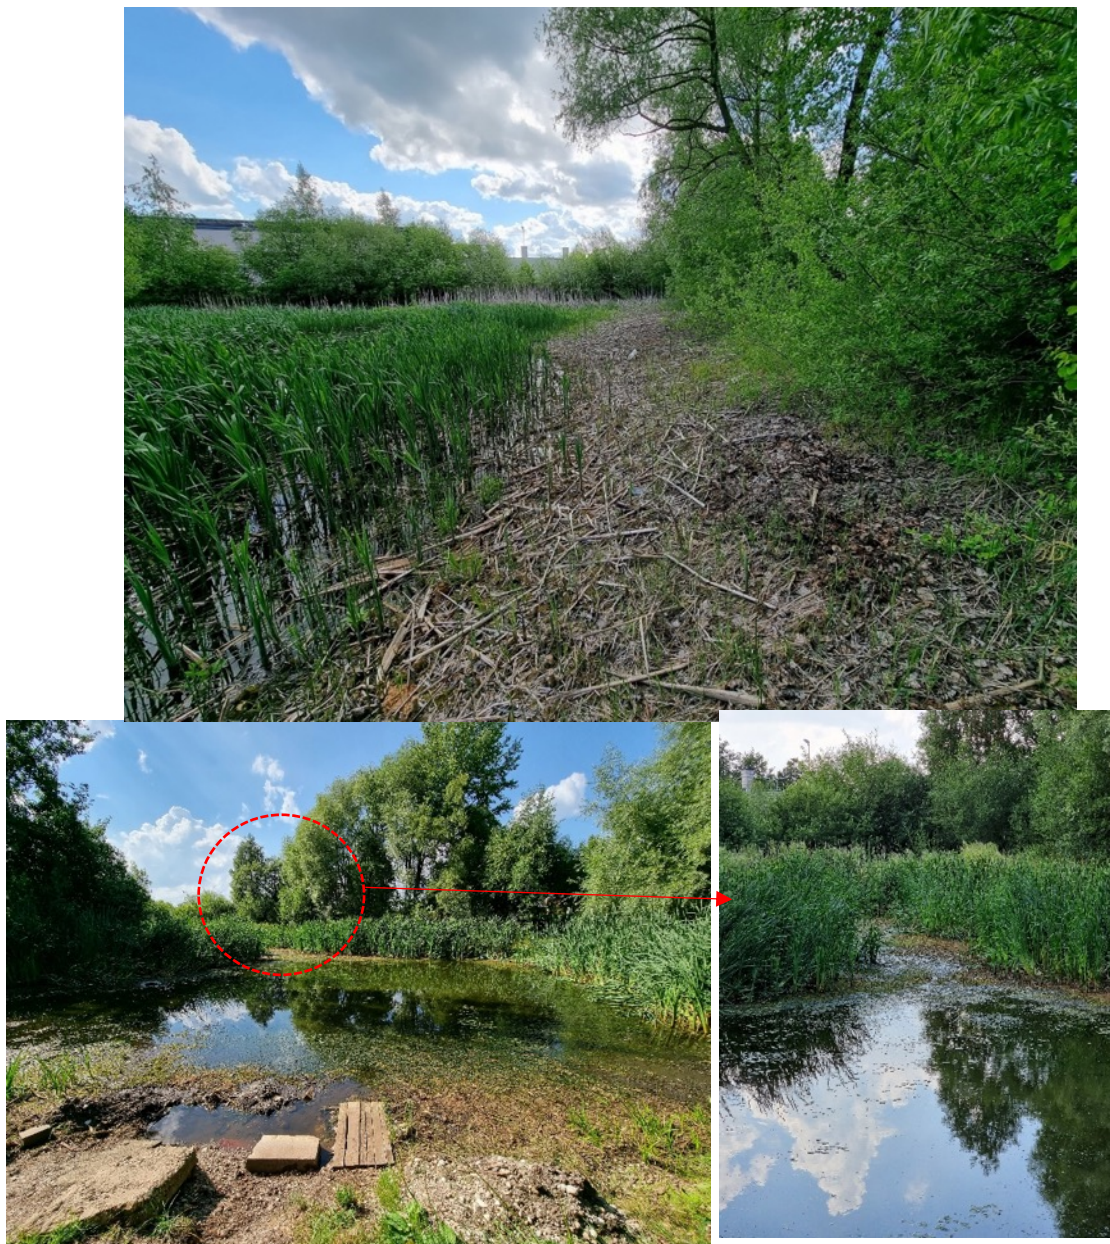
Visiting the Green pond, low water table in spring and even severe lack of water in summer and autumn was noticed. Looking to wide eulittoral it is clear that water table had been dropped for 40-60 cm or even more in May 2021. Lack of water was is even more obvious in July, when submerged macrophytes appeared into the air (Figure 105).

*Figure 105. Anykščiai Green pond suffered from the lack of water in 2021 (Photo A. Balevičius)*

Various theories were elaborated regarding this question, but the most believable reason is that some years ago during the reconstruction of the police office building and yard nearby, the surface water runoff was redirected to the opposite direction than the Green pond. Also it could be that during the reconstruction of the police building the groundwater drainage system was installed around its basement. Therefore, more detailed hydrogeological research could be needed if the situation won't go better next years.

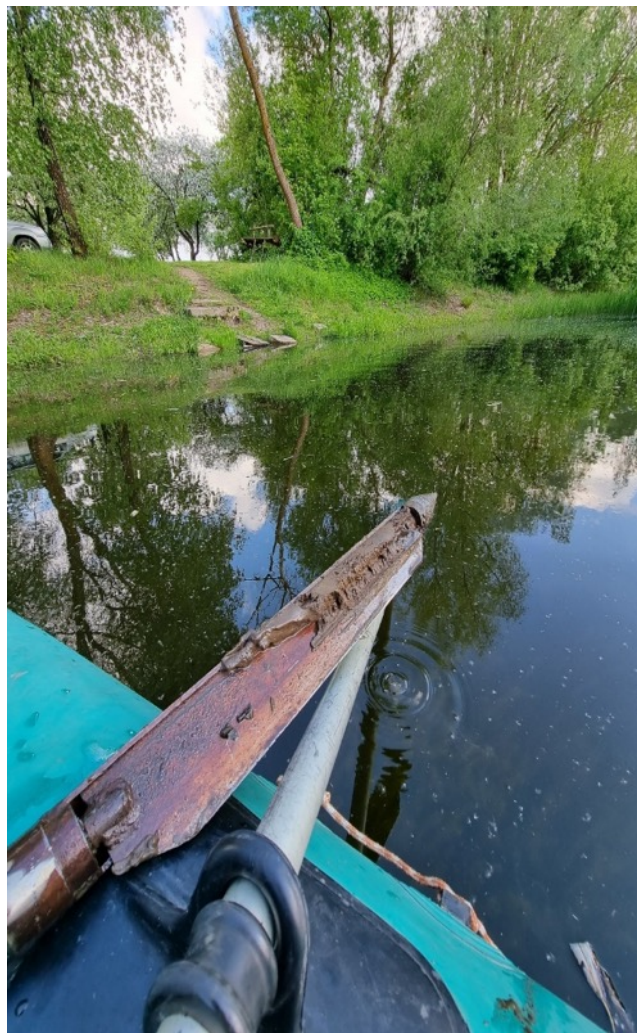
Figure 106. *Measuring thickness of accumulated sludge (Photo: A. Balevičius)*

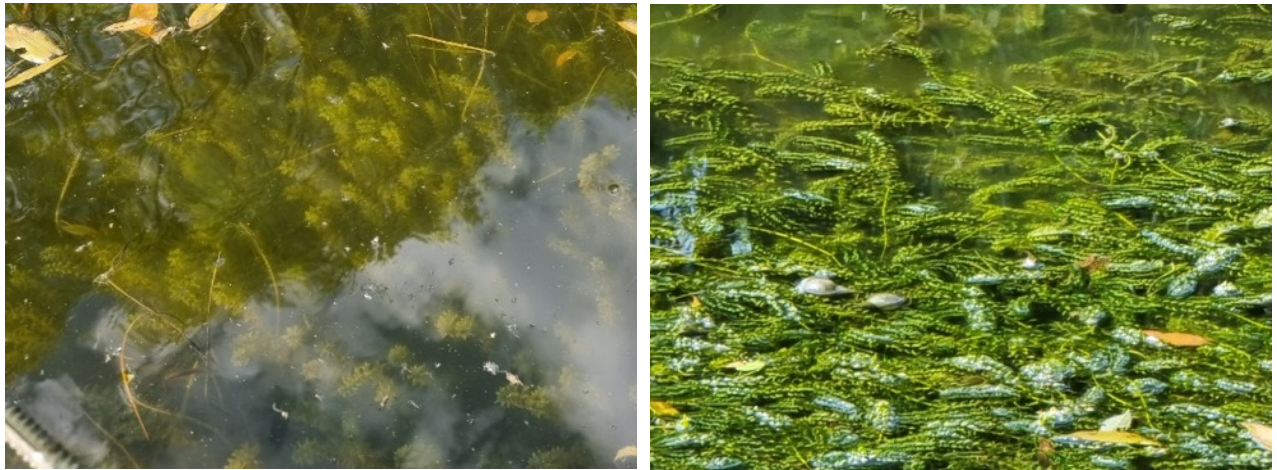
As ashleaf maple is a very competitive species which outcompetes natural tree and scrub species, it is recommended to cut ash-leaf maple growing near the Green pond. Canadian waterweed (*Elodea canadensis*) is another invasive species found in the Green pond (Figure 112 and 113). As the monodominant stands of Canadian waterweed predominate on the whole bottom of the Green pond, it outcompetes the other limnoid species. In order to increase plant diversity of the Green pond, there is a need to regulate amount of *Elodea* stands.

Figures 112. and 113. *Canadian waterweed forms dense monodominant stands on the bottom of the Green pond (Photo: Balevičius)*

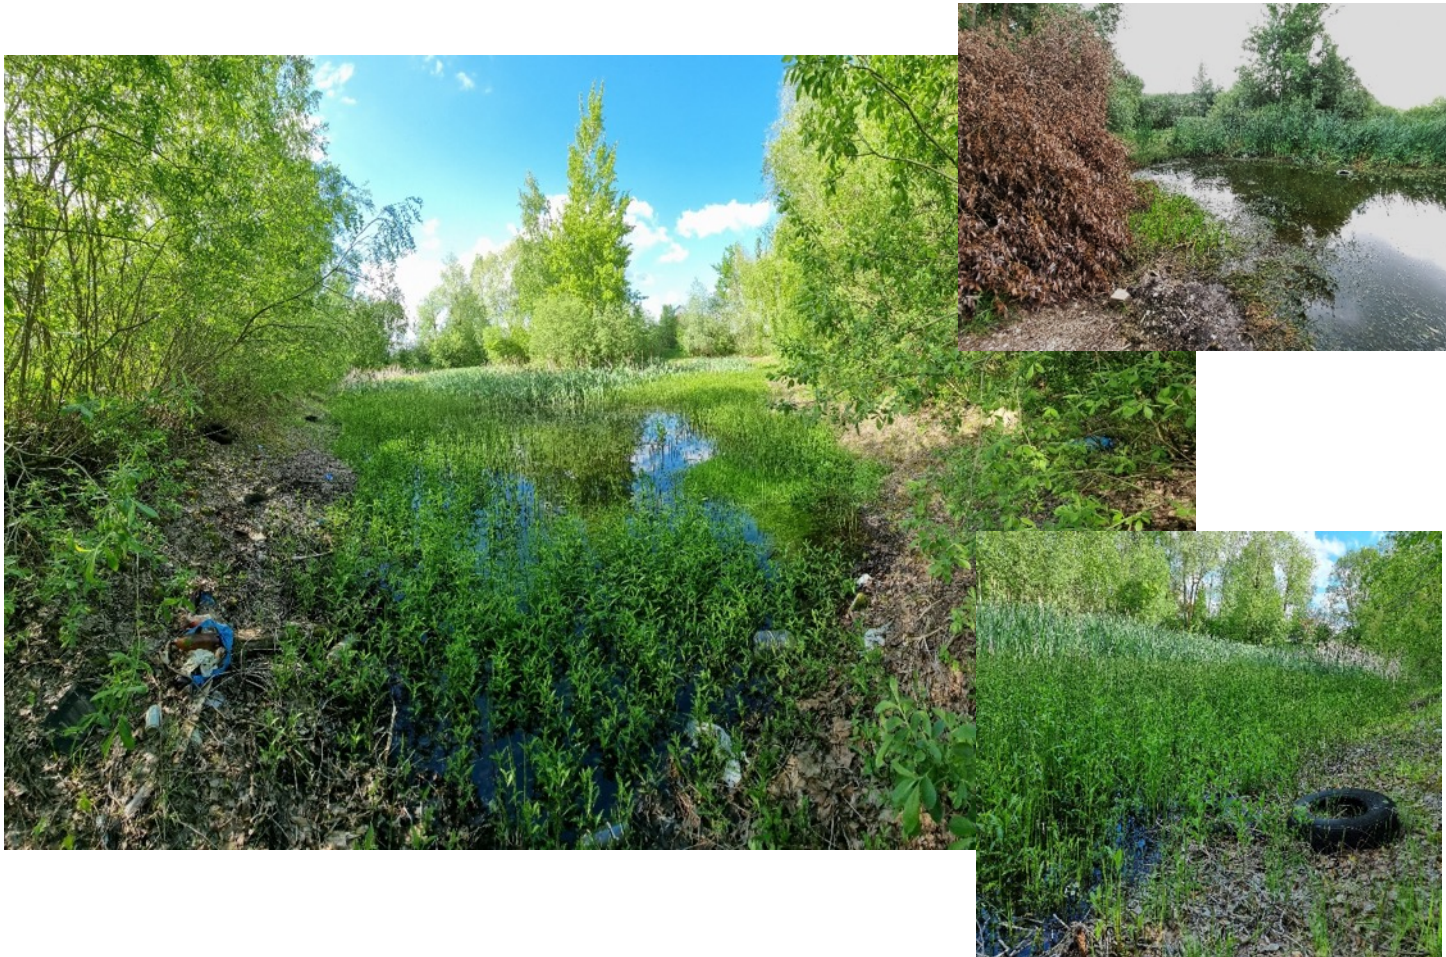
Significant anthropogenic pollution of the Green pond by different household waste was observed (Figure 114). Luckily, most of the rubbish looks to be from the past, neither present pollution.

*Figure 114. Territory around the Green pond is polluted by various rubbish (Photo: A. Balevičius)*

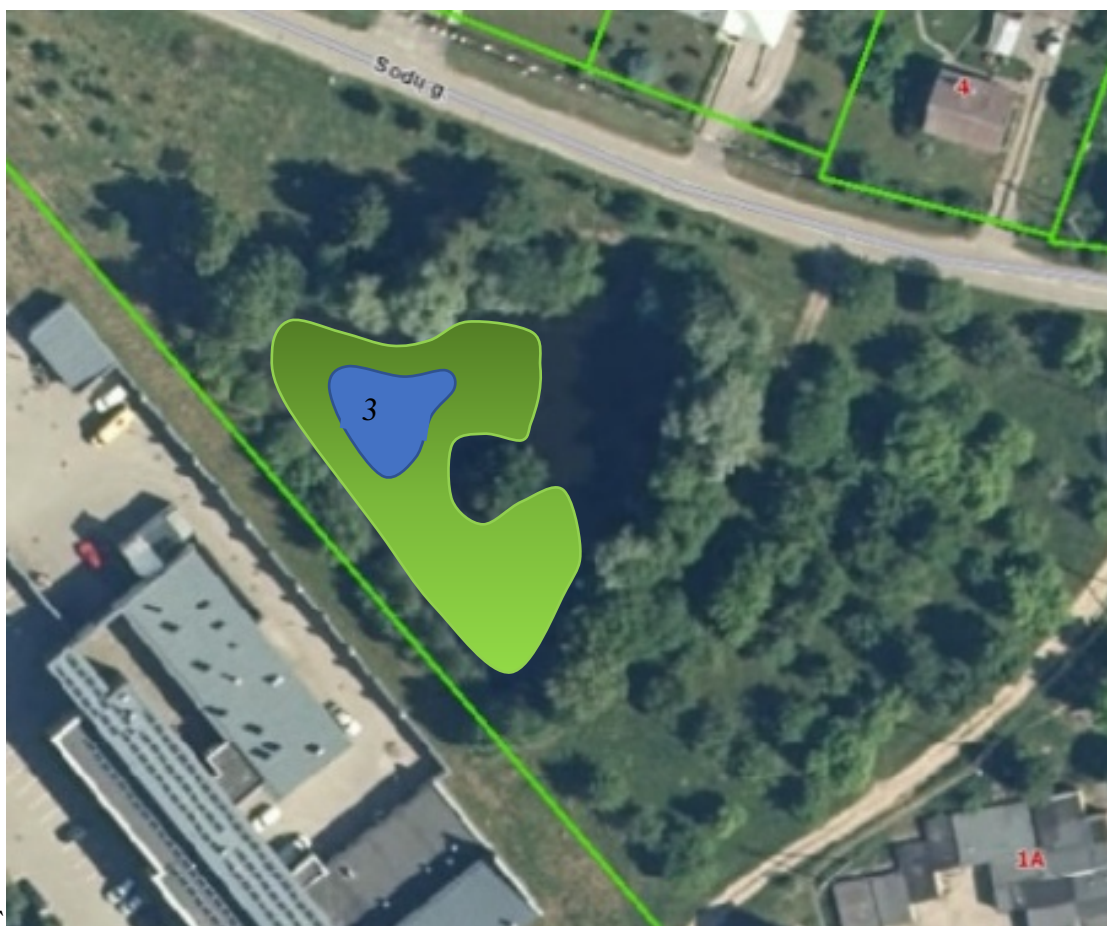
Figure 115. Overgrown area of the Green pond to be cleaned (Base orthophoto map from [www.maps.lt](http://www.maps.lt))

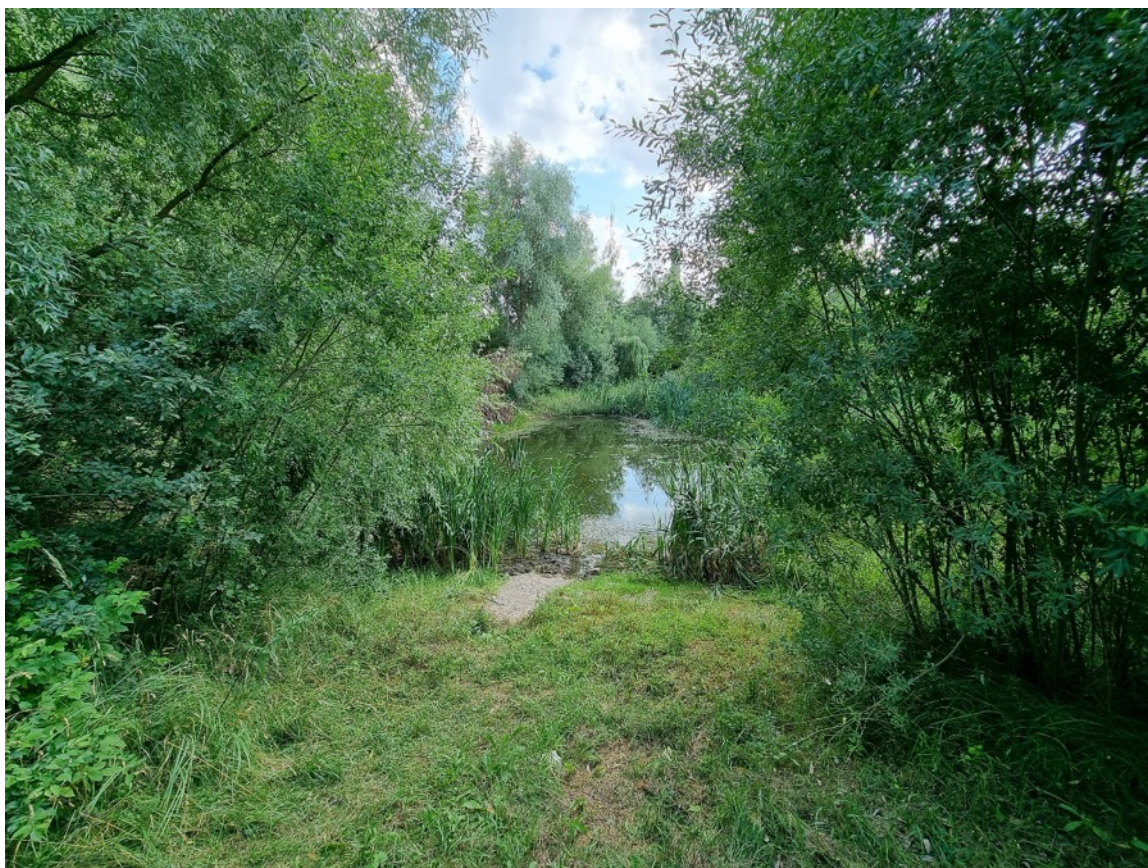
The territory surrounding the Green pond is overgrown by the ring of dense trees and scrubs (Figure 116).

Figure 116. Anykščiai Green pond surrounded by ring of dense scrubs and trees (Photo: A. Balevičius)

Most of trees are of valuable species (except of invasive *Acer negundo*) and must be left untouched, but the scrubs in many places are too dense and must be cleaned accordingly to the plan prepared by specialists of Anykščiai municipality. In order not to disturb nesting birds, invasive trees and excess scrubs must be cut in autumn or winter.

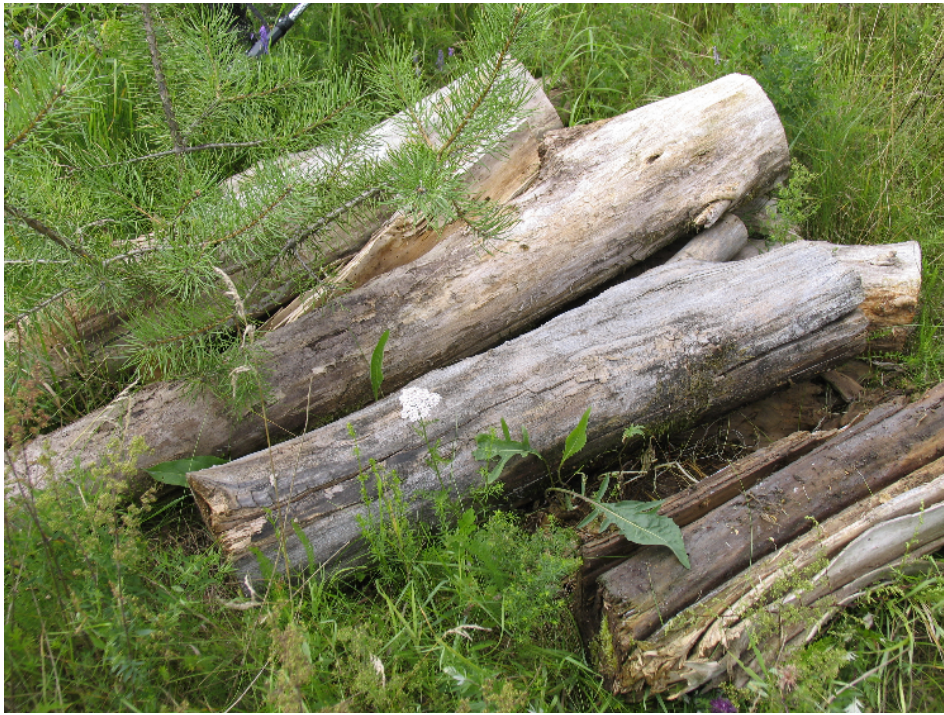
6. Removing invasive species, such as ashleaf maple, to encourage the growth of native species.
7. To improve wintering conditions for amphibians and reptiles, artificial shelters are recommended. Once the Green Pond is cleaned and its banks cleared of macrophyte growth, the number of natural shelters needed by amphibians and reptiles will decrease. This loss will therefore be compensated by the construction of 4-6 shelters (Figure 117) made of cut tree logs of varying thicknesses and stacked branches on the shore of the Green Pond.

*Figure 117. Simple but effective: an artificial shelter for amphibians (Photo: J. Rimšaitė)*

It is useful to use locally felled wood (rotten logs and branches of taller shrubs are also suitable) that will appear during the clean-up. Gaps between branches in the pile can be filled ('insulated') with fallen leaves. Some of the shelters can be supplemented with nearby stones that store heat, so reptiles use them as warming places. Shelters should be sited in partly shaded areas, approximately 5-10 m from the shoreline of the pond (Figure 118).

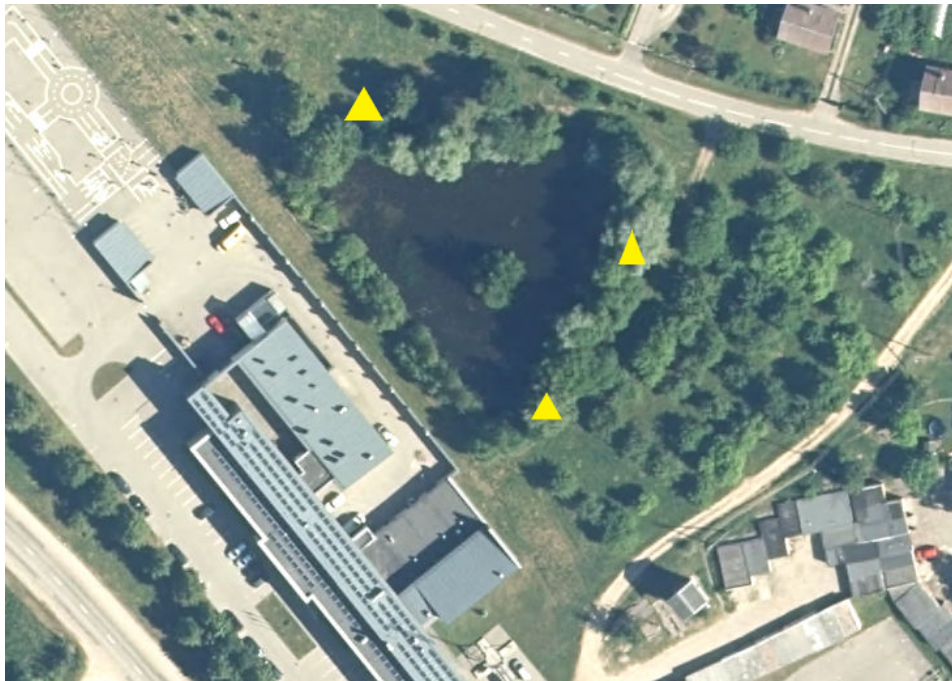
*Figure 118. Approximate locations of artificial shelters (Basic orthophoto map from [www.geoportal.lt](http://www.geoportal.lt))*

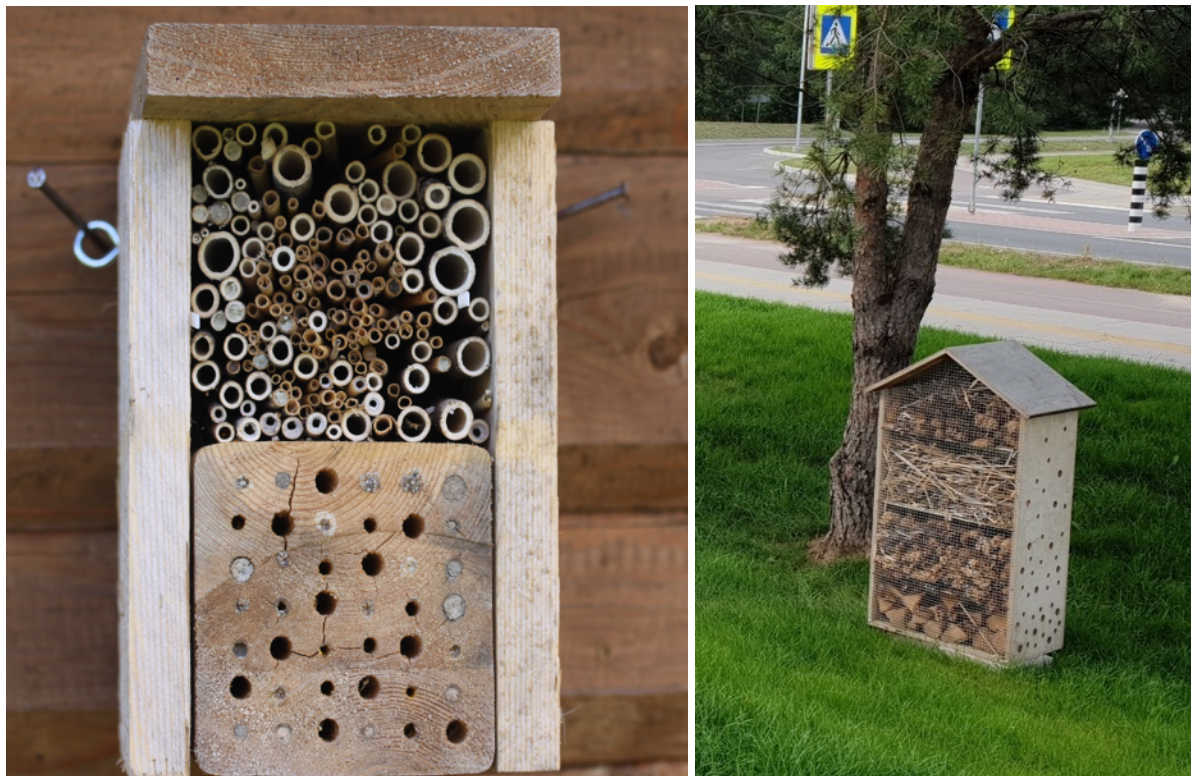
To attract more insect species to the Green Pond, some "insect hotels" could be set up. "Insect hotels" are man-made structures designed to shelter insects (Figure 119). Most 'hotels' consist of several different

sections that provide nesting opportunities for insects - especially in winter, offering shelter or refuge to many types of insects such as pollinators, beetles and others.

*Figures 119 and 120. Insect hotels (Photos P. Ivinskis, A. Balevičius)*

The insect hotel can be used as a great educational tool. Insect hotels should be located in an open, well-heated, sunny place. It is also recommended to involve the local community in the production of insect hotels, e.g. students from nearby schools during biology and woodworking lessons.
